OOAMA AIRMUNITIONS LETTER  
NO 136-11-56G

SUBJECT: Advance Explosive Ordnance Disposal Technical Information

(U) SUMMARY OF NUCLEAR WEAPONS INCIDENTS (AF FORM 1056) AND RELATED PROBLEMS - JANUARY 1961

NWI-61-1

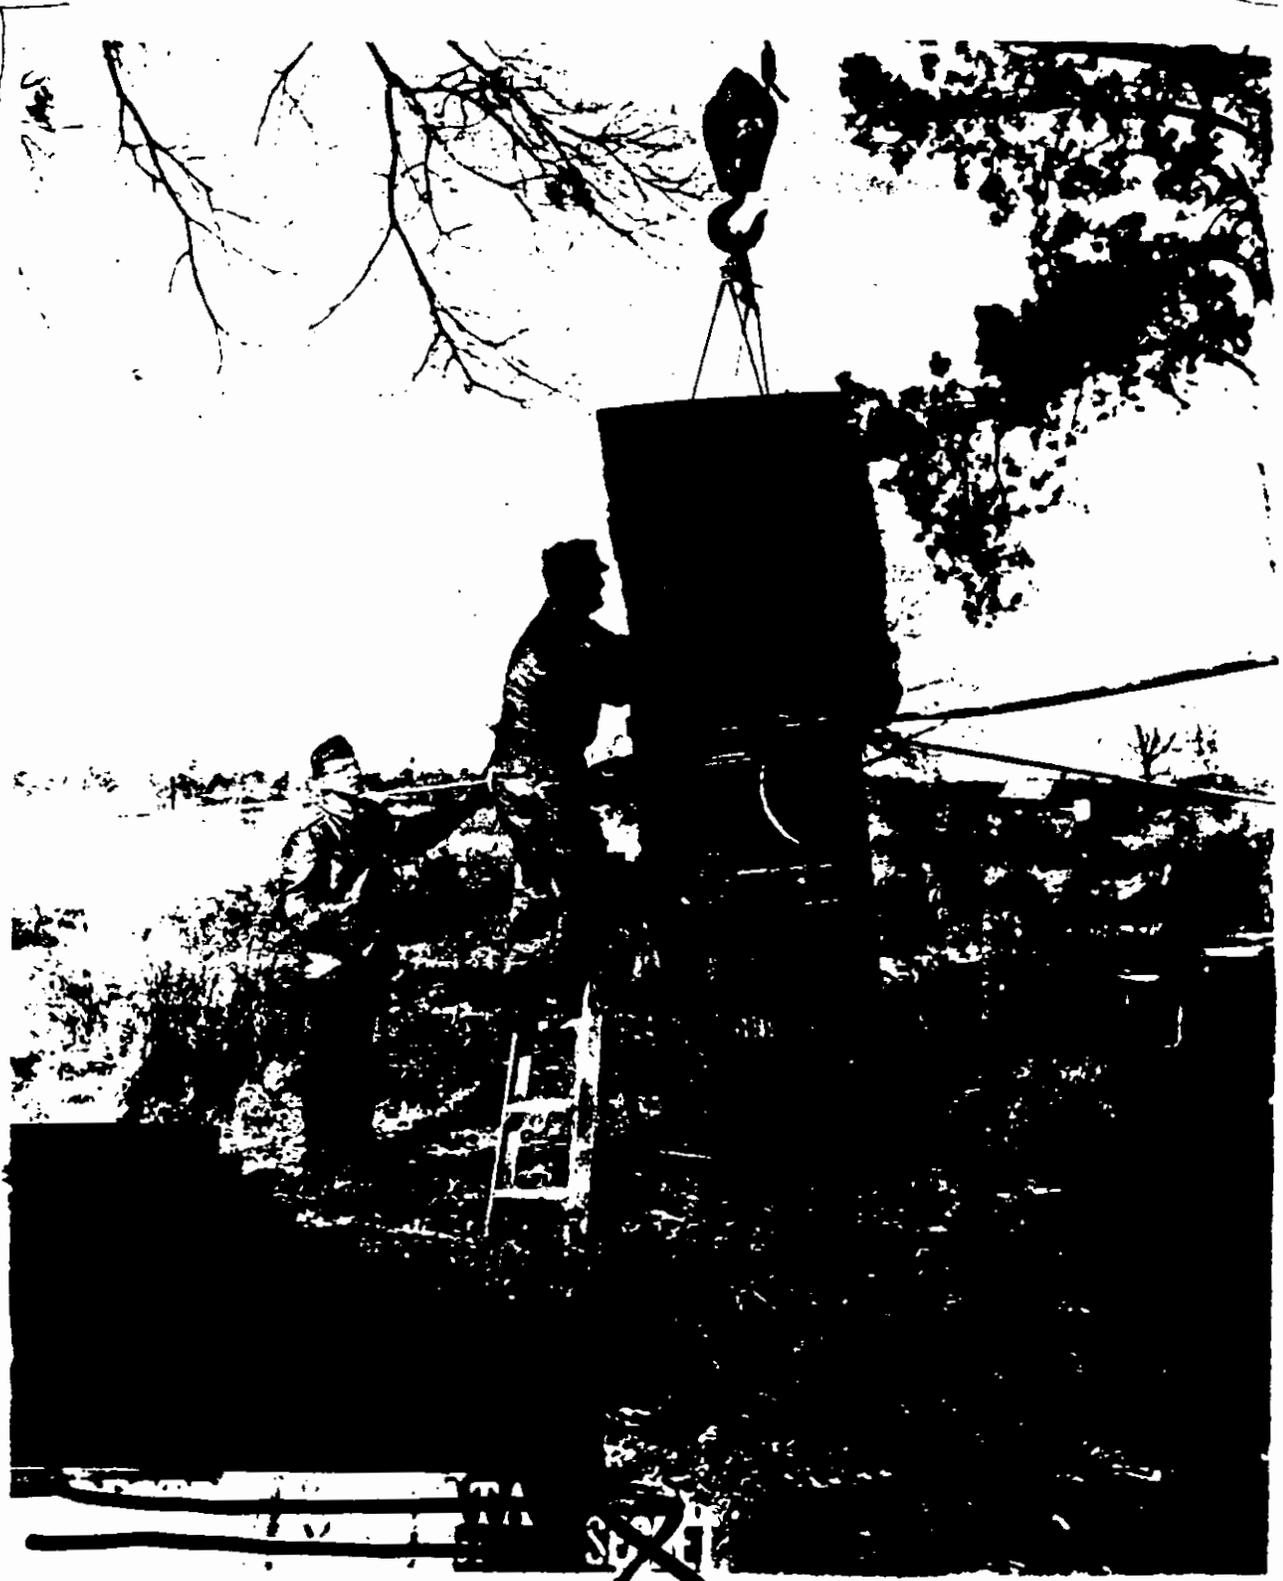
FIGURE 5. Primary Removal.
