**AIRCRAFT
ACCIDENT INVESTIGATION BOARD
REPORT**

**US ARMY UH-60
BLACK HAWK HELICOPTERS
87-26000 AND 88-26060**

VOLUME 4

TECHNICAL OR ENGINEERING EVALUATIONS

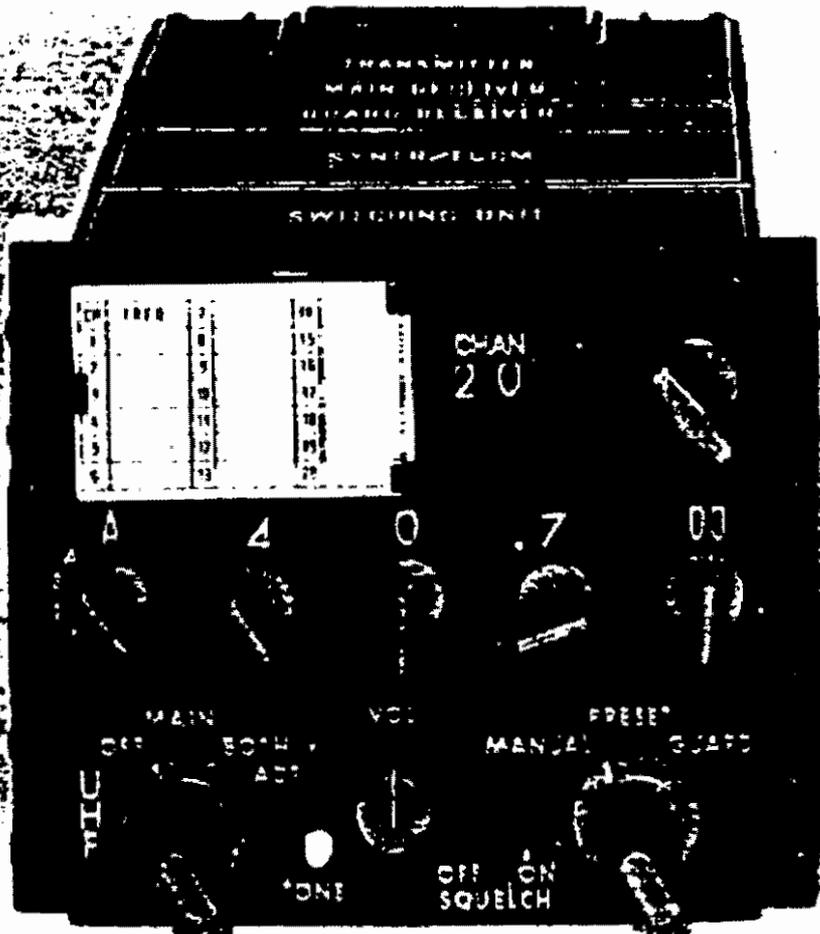
ARC-164 Comparison *White Triangle*

a. The RT-1167 faceplate is of different construction than the RT-1168 faceplate. The RT-1167 faceplate has grommets and a different channel selector switch which enables it to be rain-proof. The RT-1167 actually gets a rain test in the factory. The RT-1168 gets humidity testing only, no rain.
