**AIRCRAFT
ACCIDENT INVESTIGATION BOARD
REPORT**

**US ARMY UH-60
BLACK HAWK HELICOPTERS
87-26000 AND 88-26060**

VOLUME 4

TECHNICAL OR ENGINEERING EVALUATIONS

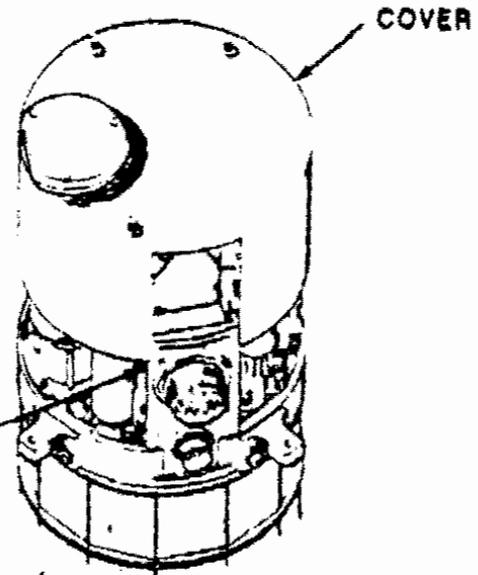
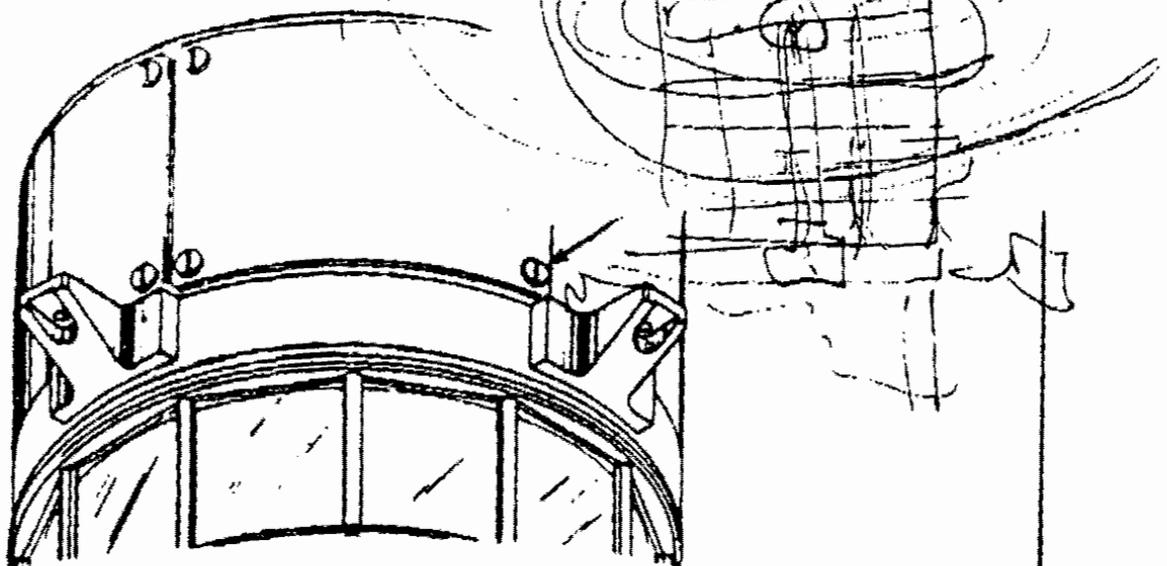
2. The lower protective cover had a pierced hole about .720 inches in diameter. When traced through another hole was found, 630 inches in diameter, in the fan motor outer duct damaging the EMI filter of the motor. Some sort of projectile ripped through the cover and stopped at the motor. No fragments were found. See photo's.

3. All circuit card assemblies (CCA), A6, A7, A8, and A9, were badly burnt. The basic material started to disintegrate. The thumb wheel to reprogram the jam programs was totally destroyed and melted beyond recognition. It could not be determined what jam program was set. The card cage assembly was covered with a thick, (about 1/16 inches) of black residue, tar like looking material. The high/low speed motors, relay and EMI filter were also coated with this material. Nothing was coated externally, however, when the cover was removed the inside of the cover and the components were all coated. No chemical analysis was made of the coating. See photo.

4. Low speed modulator lens were totally destroyed. No lens pieces were found. The upper and lower bearing assemblies were intact. Bearings rotated and were not seized. The alignment pins on the upper bearing were sheared and one on the lower was also sheared. Such a condition could affect the torque of the motor causing the system to INOP and the Low Freq. BIT to trip, if the system was operating. See photo's.

5. High speed modulator slotted assembly was distorted and a few sections were broken off. The bearing package looked good and both bearings rotated freely. See photo's.

7. Two end extremes of the IR source with two broken pieces of the outer envelop were the only parts remaining of the assembly. See photo's.

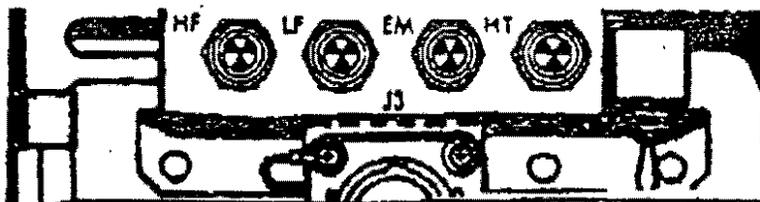
2. The only component of the AN/ALQ-144(V) IRCM that was delivered to NV&ES Directorate was the transmitter assembly, for failure analysis. The other major components, such as the operator control unit (OCU), and transit/carrying cases, were not delivered. The transmitter was so badly burnt and damaged, even though intact, that a failure analysis could not be made other than to say that with all the 4 Built In Test (BIT) indicators not tripped (normal operation), meant that the system experienced an instantaneous total failure of electrical power or the system may not have been turned on. This could only be verified by the position of the ON/OFF switch of the OCU which was not available and also by the setting of the IRCM circuit breakers located in the A/C cockpit. See the photo of BIT indicators of the transmitter upon receipt and the BIT functions NORMAL versus FAILURE shown below:
